FIRE SAFETY FOLLOW UP INSPECTION

Factory Name	Arunima Sportswear Ltd		Accord ID	9707
Address	Zirabo, Savar, Dhaka			
Inspection Date	22/04/2014		Report Received Date	
Date of 1st Follow-up	29/10/2015	Date of 2nd Follow-up	13/03/2016	
Date of 3rd Follow-up	21/03/2017	Date of 4th Follow-up	03/07/2017	
Date of 5th Follow-up	09/11/2017	Date of 6th Follow-up	03/06/2018	
Date of 7th Follow-up	13/03/2019	Date of 8th Follow-up		
Date of 9th Follow-up		Date of 10th Follow-up		
Date of 11th Follow-up		Date of 12th Follow-up		
Date of 13th Follow-up		Date of 14th Follow-up		
Inspected by	Mahfuza Khanom

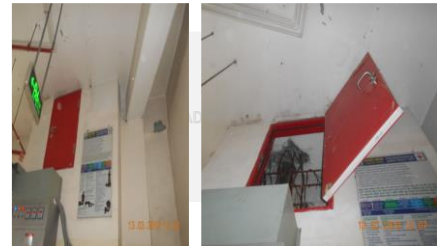
Item No	Accord Observation	Accord Recommendation	Timeline given by Accord	Comments after Physical Inspection	Supposed to complete(DD/MM/YYYY)	Final Action Plan (Factory)	Status on the date of Inspection	Pictorial Evidence
1	The electrical chase was not closed with fire rated construction.	Close shafts with 2 hour fire rated construction and fire rated access doors.	9/4/2014 12:00:00 AM	<p>Present Status: In progress.</p> <p>On 21th March 2017 As action plan of the factory: Corrected. (Factory has rated the electrical shaft as per Accord guide line).</p> <p>On 03/07/2017: Corrected.</p> <p>On 09/11/2017: Corrected</p> <p>On 03/June/2018: Corrected</p> <p>On 13/03/2019: Corrected as per previous follow-up. Note: Factory shall ensure all door accessories functionality and authentic certification for all door assemblies.</p>	'31/01/2017	Corrected	Corrected

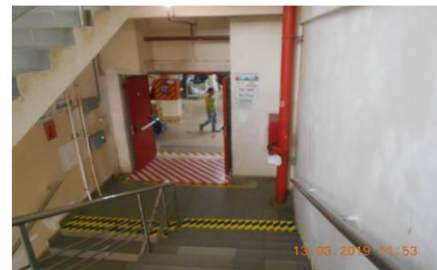
3	Both stairs are equipped with sliding gates whose tracks pose a tripping hazard. The north stair includes a 10 inch deep fire hose box on the landing which intrudes in the clear width of the egress path.	Relocate fire hose cabinets so that they do not intrude into the egress clearance in the stairs. Remove all sliding gates, tracks and other noncompliant hardware to maximize clear width in the stairs and paths of egress.		<p>Present Status: Completed. The factory have to install 65 mm connection such a way that will not count as obstruction to egress path.</p> <p>On 21th March 2017 As action plan of the factory: Corrected as per previous follow-up inspection.</p> <p>On 03/07/2017: Corrected as per previous follow-up inspection.</p> <p>On 09/11/2017: Corrected</p> <p>On 03/June/2018: Corrected as per previous report. Factory management shall relocate the non-compliant fire hose cabinet situated in the exit stair.</p> <p>On 13/03/2019: Corrected.</p>	'02/06/2015	Corrected	Corrected

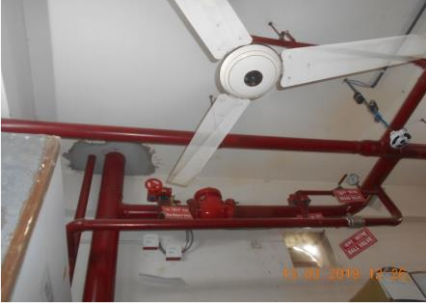
Item No	Accord Observation	Accord Recommendation	Timeline given by Accord	Comments after Physical Inspection	Supposed to complete(DD/MM/YYYY)	Final Action Plan (Factory)	Status on the date of Inspection	Pictorial Evidence
8	Wall and floor penetrations are not protected with firestop systems. Spot removing room is separated from production area by non rated door. The wall separating dining (E4) and storage (H2) has unprotected openings which are not capable of providing required fire separation. The walls separating boiler shed from surrounding occupancy are not provided with 0.75 rated opening assemblies. The walls of the generator room on ground floor and generator room on basement floor of three story building have unprotected openings.	Install listed firestop systems at every penetration through fire rated walls and floors. Install fire doors in doorways through rated walls. Provide opening protection at all windows and other openings on all the fire rated walls across the entire premises. If these openings are not required, close these.	9/25/2014 12:00:00 AM	Present Status: It has found same as it was before. On 21th March 2017 As action plan of the factory: Corrected. (Factory has sealed all opening). On 03/07/2017: Corrected. On 09/11/2017: Corrected On 03/June/2018: Corrected On 13/03/2019: Corrected as per previous follow-up. Note: Factory shall seal all unsealed openings through floor/ceiling.	'30/04/2016	Corrected	Corrected

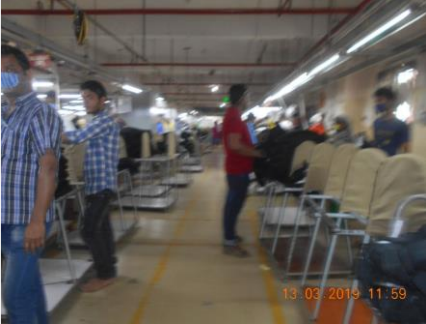
9	Height of the highest occupied level of the 9 story main building is 25.12m (82.4 ft). The whole building needs to be protected by automatic sprinkler system. Sprinkler system is not provided in any part of the building.	Provide automatic sprinkler systems throughout the buildings with an occupied floor greater than 23 m (75 ft) above the finished grade. The installation of sprinkler protection should be conducted in phases. The first phase would be to protect all storage areas. Prior to installation, the system should be properly designed by a qualified fire protection engineer and plans should be submitted to the Alliance for review.	2/24/2015 12:00:00 AM	On 03/07/2017: Sprinkle system installation work has been almost completed. On 09/11/2017: The system is not installed as per the requirement and functional as well. On 03/June/2018: Important observation after T&C on installed Sprinkler System: Sprinkler heads were found obstructed due to false ceiling, On top floor, installed sprinkler heads were found inactivate as protective cap was present. Physical presence of flow switch & drain valve was not as per standard. Coverage & spacing of sprinkler shall have to be ensured as per NFPA-13 where applicable. On 13/03/2019: Factory shall apply for T&C to Accord after modification of the system.	'13/08/2016	In Progress	In Progress

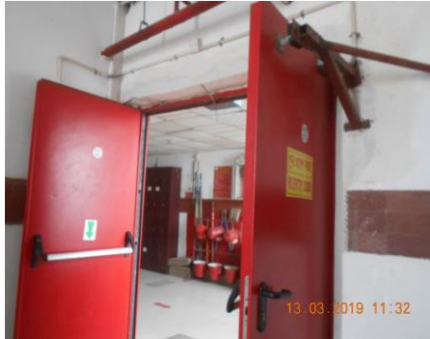
16	The main production building has 9 stories, but doors are not provided with re-entry. Stair doors with re-entry are required in at least 2 floors according to Alliance Standards Part 6 Section 6.8.3. The buildings other than the main building have less than 6 stories, therefore re-entry is not required for those buildings.	Every door in a stair enclosure serving more than 5 stories shall be provided with re-entry unless it meets the following requirements. Stair doors may be permitted to be locked from the stair (ingress) side that prevents re-entry to the floor provided at least two floors allowing re-entry to access another exit are provided, there are not more than 4 stories intervening between re-entry floors, re-entry is allowed on the top or next to top level, re-entry doors are identified as such on the stair side, and locked doors shall be identified as to the nearest re-entry floors. When the discharge floor is determined to be a required re-entry floor using the above requirements, re-entry does not have to be provided back into the building on this level.	9/25/2014 12:00:00 AM	Present Status: Completed On 21th March 2017 As action plan of the factory: Corrected as per previous follow-up inspection. On 03/07/2017: Corrected as per previous follow-up inspection. On 09/11/2017: Corrected On 03/June/2018: Corrected On 13/03/2019: Corrected as per previous follow-up.	'29/10/2015	Corrected	Corrected

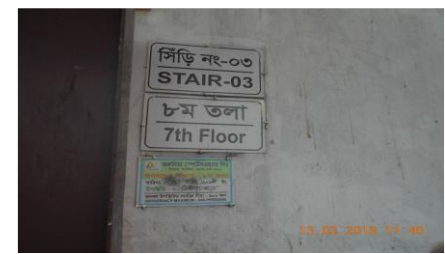
22 Occupant loads are not posted in a conspicuous space near the main exits or exit access doorways as required in Alliance Standard Part 6, Section 6.4.4.

Present Status: In progress. The factory has posted occupants loads in the production floor only near south stair.
 On 21th March 2017 As action plan of the factory: Corrected.
 On 03/07/2017: Corrected.
 On 09/11/2017: Corrected
 On 03/June/2018: Posted
 On 13/03/2019: Corrected.

Post the occupant load for every assembly and production floor in a facility in a conspicuous space near the main exit or exit access doorway for the space.

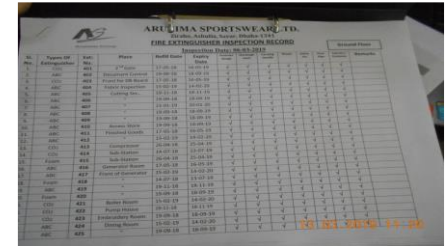
23 Extinguishers are inspected monthly by the factory's concerned people. But no document was found in support of i) annual maintenance of extinguishers by a servicing agent and ii) annual testing of nozzle of CO2 extinguisher. These are required as per NFPA 10.

Present Status: Completed
 On 21th March 2017 As action plan of the factory: Corrected as per previous follow-up inspection.
 On 03/07/2017: Corrected as per previous follow-up inspection.
 On 09/11/2017: Corrected
 On 03/June/2018: Corrected
 On 13/03/2019: Corrected.

Fire extinguishers are to be inspected, tested and maintained in accordance with NFPA 10, Chapter 7 as required in Alliance Standard Part 13, Section 13.10.3.

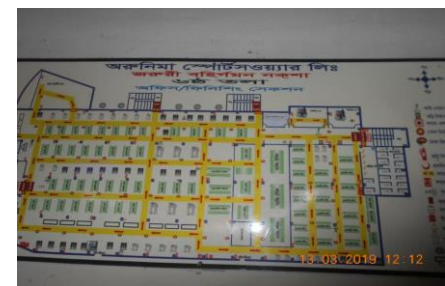
24 Through the interview, it was noted that the workers are aware of the evacuation procedure upon commencing the alarm. However, no procedure defining the evacuation process was available.

Present Status: Completed
 On 21th March 2017 As action plan of the factory: Corrected as per previous follow-up inspection.
 On 03/07/2017: Corrected as per previous follow-up inspection.
 On 09/11/2017: Corrected
 On 03/June/2018: Provided
 On 13/03/2019: Corrected.

Develop an emergency evacuation plan which includes duties and responsibilities of various people/groups, interfacing between groups and fire brigade, headcount and identification of trapped victims, physically disabled people and their rescue, etc. and all components required by the Alliance Standards and communicate the plan to all employees.

The evacuation plan shall include provisions to assist physically disabled persons. A list of all employees with physical disabilities shall be kept by the Fire Service Director.
